Subject: B767 Engine Fuel Feed Tube and Front Spar Fitting Electrical Bonding Test – Proposed Rule

Reference: A/ Rules Docket No. FAA-2004-19680
B/ Boeing Service Bulletins 767-28A0071 & 767-28A0072
C/ NPRM Docket No. 2004-NM-215-AD

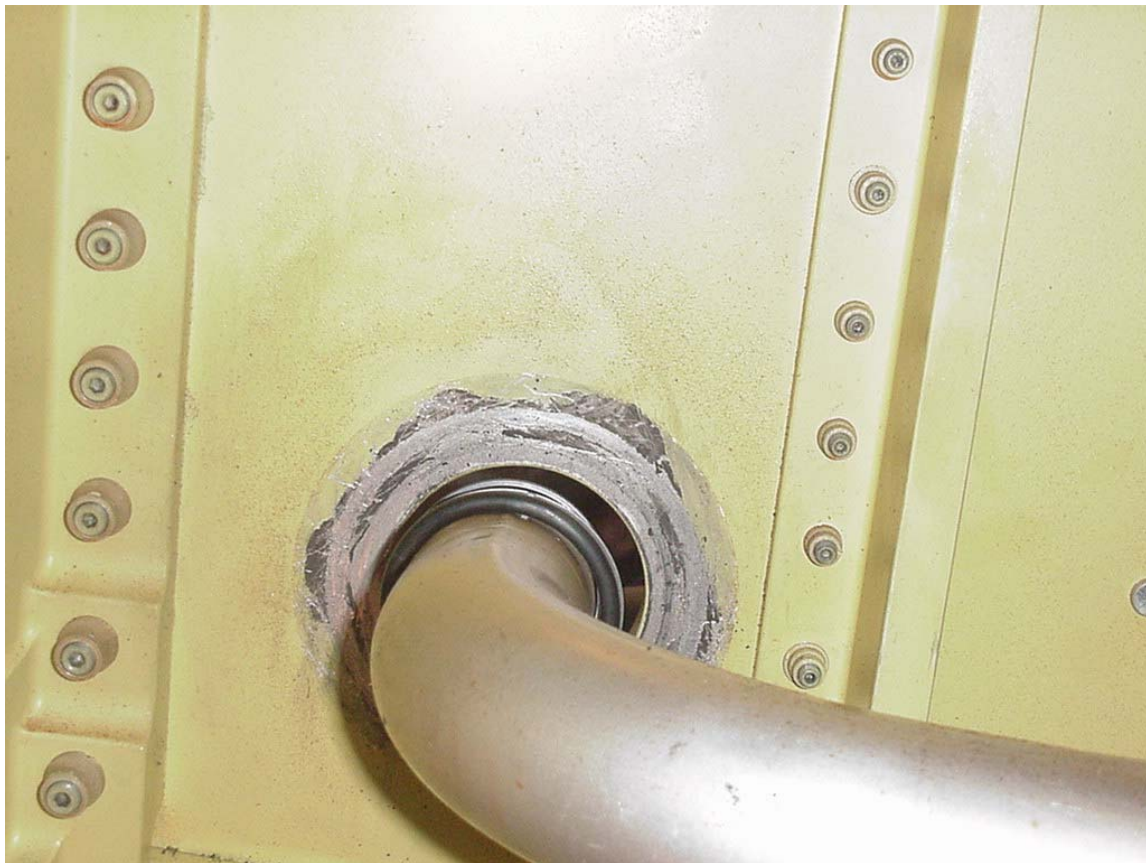
FIGURE 1

- These alternate rework instructions were evaluated and validated during the accomplishment of the ref. /B/ bulletins on the Continental Airline's airplane. Refer to the attached figures, one through four, that show the affected areas on the front spar.

- The preparation of the mating surface area on the dry bay side of the front spar for bonding should be accomplished by the Cleaning Procedures 1, 2 or 3 of the Boeing Standard Wiring Practices Manual, (BSWPM), section 20-20-00. The cleaning should be accomplished by the usage of fine abrasive material, 100 grit or finer, that would remove the minimum amount of aluminum, not to exceed 0.0010 inch.
